CASE STUDY

AI & ML Base Laser

Inspection ATE

STEEL CRACK IDENTIFICATION SYSTEM

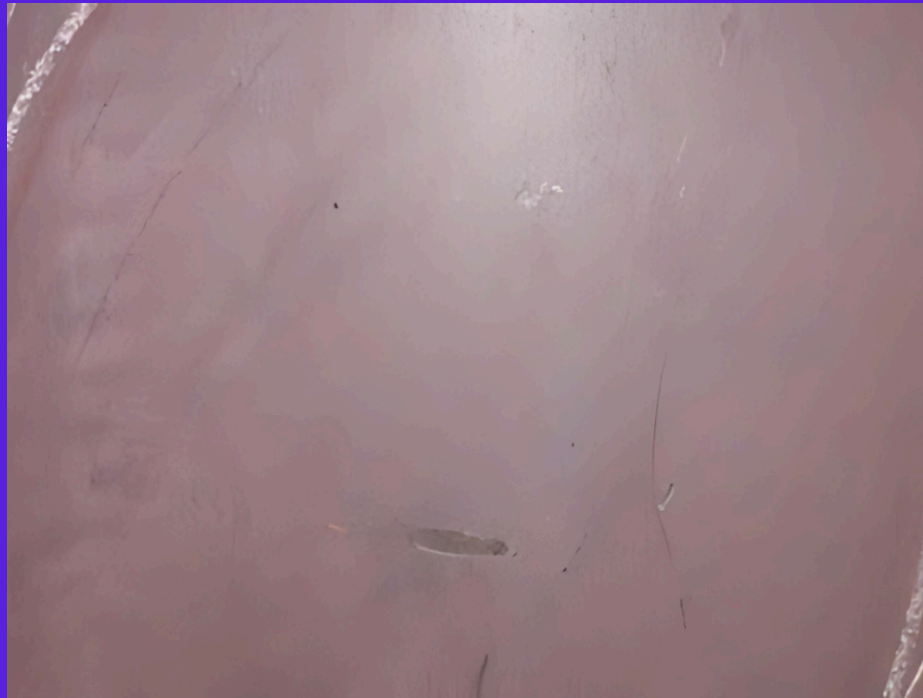
01

Longitudinal Crack
Dimensions: 5mmX500mm
Thickness: 12mm

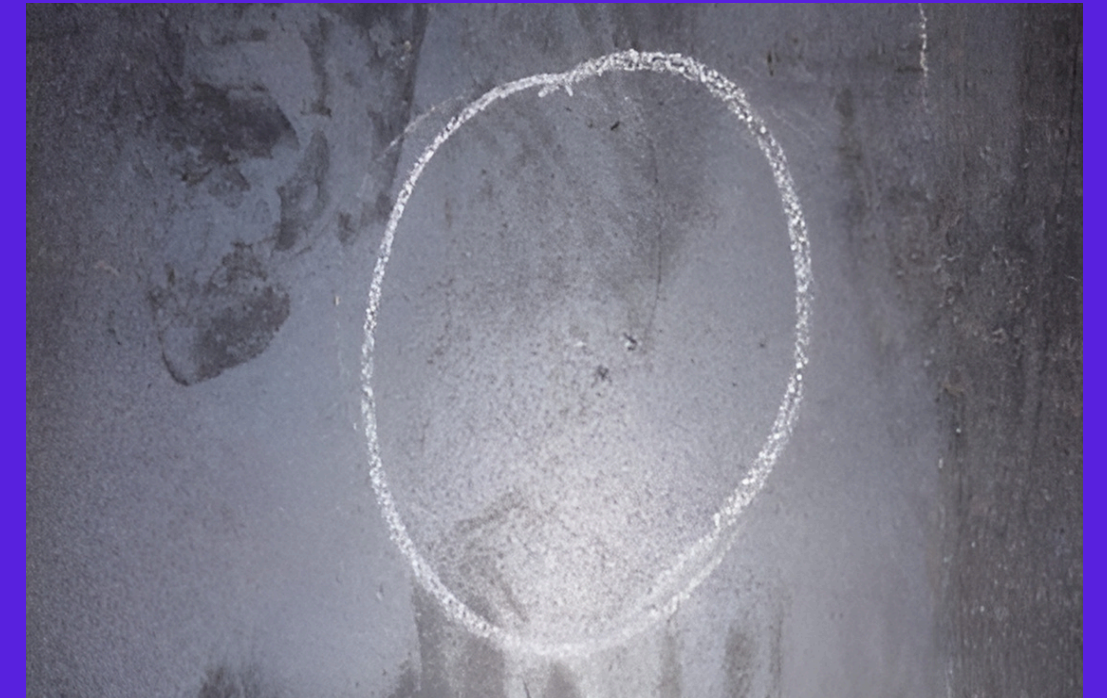
03

Pit
Dimensions: 5mmX500mm
Thickness: 16mm
